Water Harvesting and Recharge Structures in Yavatmal District

A Status Check

Authors: Ravikant Kumar and Romit Sen

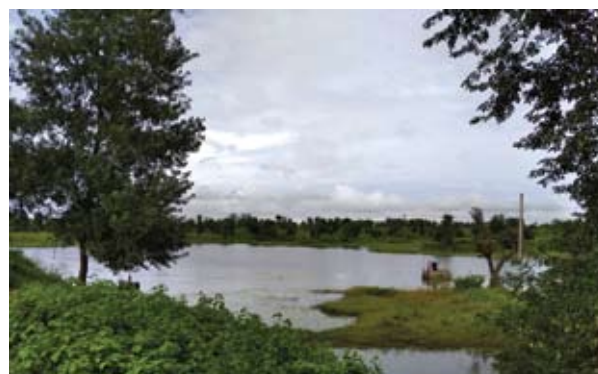
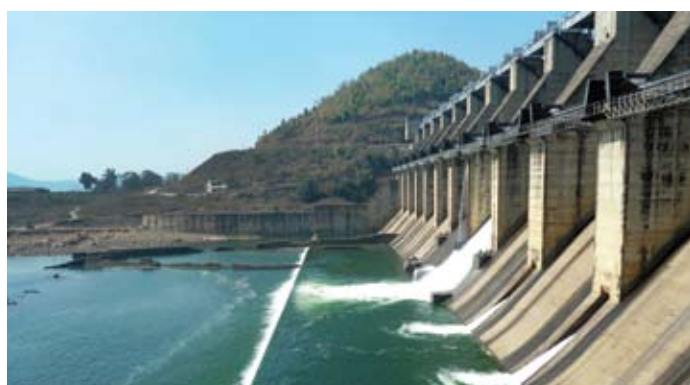
A total of 52 water storage tanks lying within an area range of 10-30 acres were mapped in the district. Out of these 12 water storage tanks (corresponding to 23.1%) lie in the recharge zone and 38 (corresponding to 73.1 %) lie in the discharge zone. Only 2 water storage structures were found to be encroached. A high percentage of water storage tanks in discharge areas meets the purpose of surface storage which is the main aim for the construction of these tanks.
